AIRTuB

Report HZ UAS activities 2019-2023

REPORT HZ UAS ACTIVITIES

DATA SCIENCE
ASSET MANAGEMENT
ENGINEERING

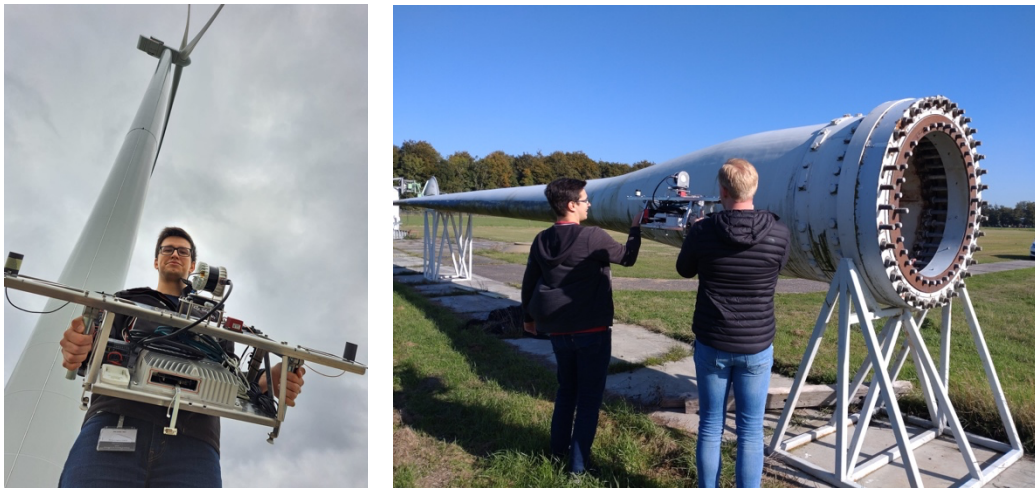
- For navigation purposes Demcon developed a lidar for making a scan of the blade and leading edge contour. In combination with the GPS data a flight path can be generated along the leading edge and towards a landing area.

Fig.3. Lidar sensor for navigation path planning purposes (Demcon Unmanned Systems)

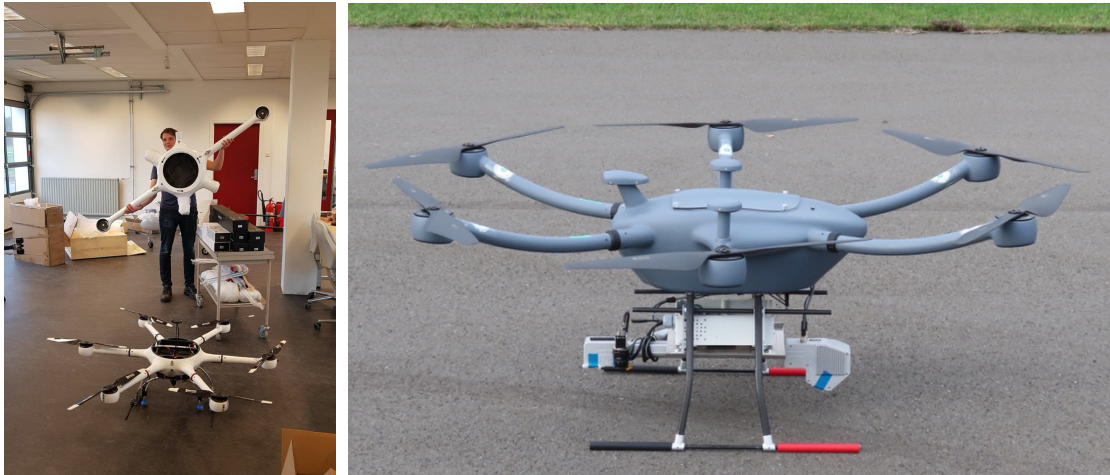
- Several drones have been chosen by NLR to fulfil the requirements for flying with the laser line scanner and with the crawler/sensor package. In Both cases the lidar sensor is designed to be combined with several types of flight missions/drones. This also accounts for the Fusion Flight controller.
 - The flight controller development was on the critical path. For risk mitigation purposes we also had the possibility to apply conventional flight controllers

Fig.6. AIRTuB and testbed drone with laser line scanner (leading edge erosion damage TU Delft) (drones: NLR)

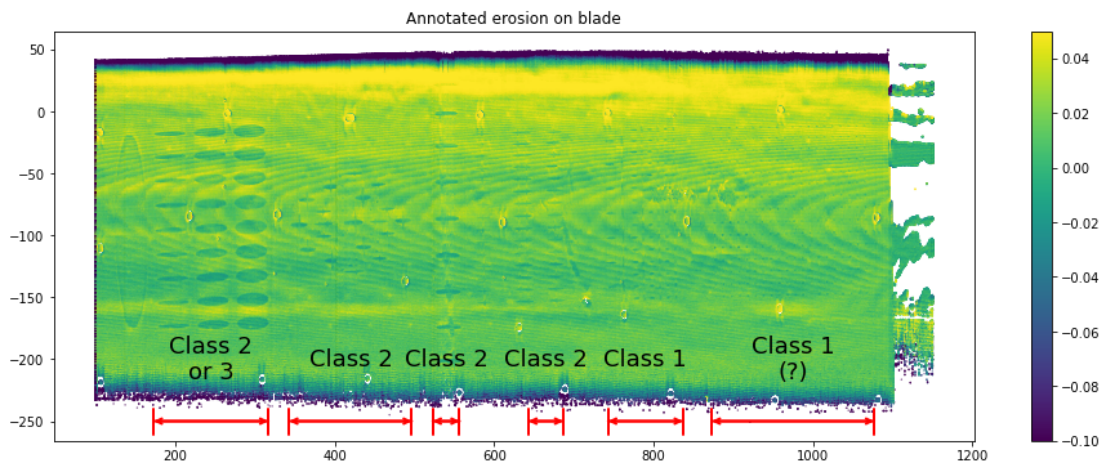
Fig.9. Scan of 1 m section of blade. Displayed is the “depth” as a varying color (z-coordinate, “color-scale”) at a specific location (x-, and y- coordinate resp horizontal and vertical). The scanning process starts at about 100 mm and ends at about 1100 mm in the x-direction.

- Hence, about 1 m of blade was scanned. In the y-direction it appears that the blade was not exactly in the middle of the camera field. However, for the process this was no problem. With respect to five classes as defined in the framework by Gaudern , erosion classes 1, 2 and (possibly) three could be found in the scan.
- After scanning this part, the resulting image was divided in slices. Each slice was labeled manually with a the known

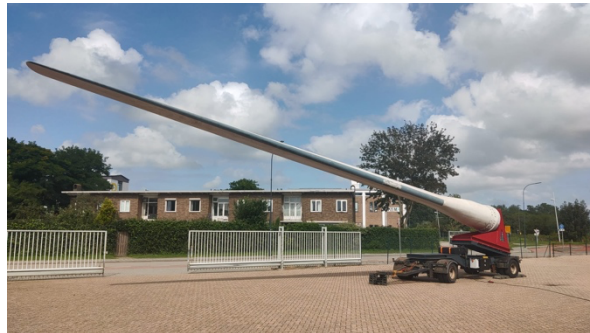
Fig.11. Mobile platform with rotatable/pitchable 22m blade

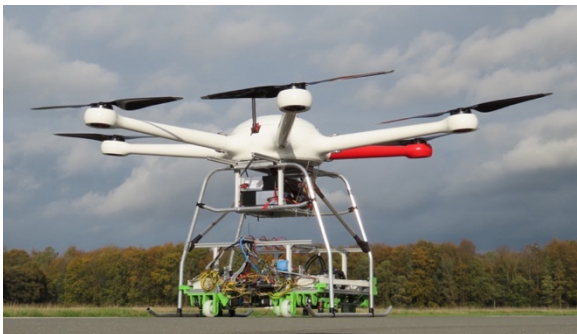
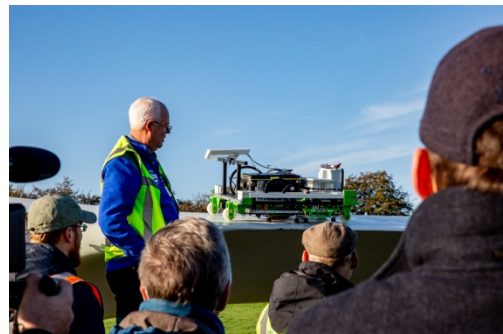
Fig.14. Drone with crawler on landing platform and crawler/sensor package on 22m wind turbine blade
