# Final report AIRTuB (Automated Inspection & Repair of TurbineBlades)

Automated Inspection & Repair of Turbine Blades

May 2023

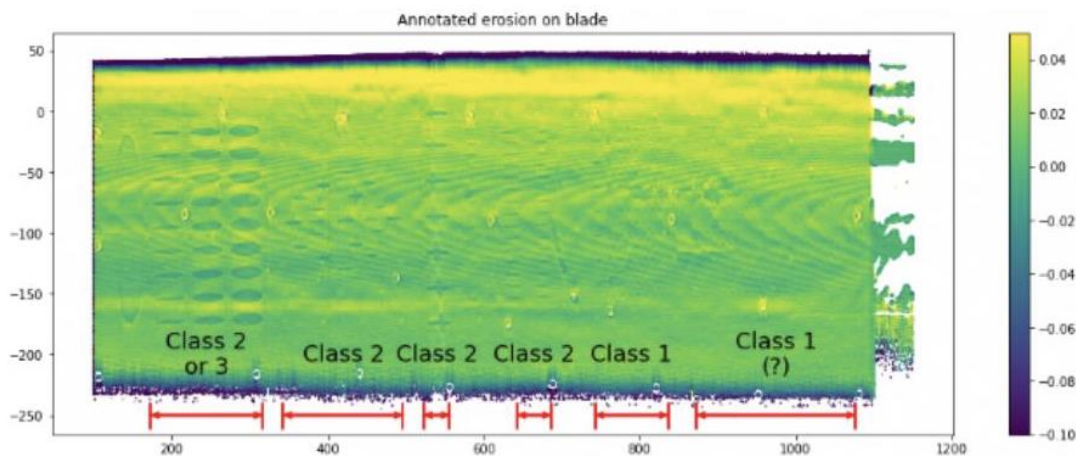
Figure 5. Laser line scan with erosion on the leading edge of a wind turbine blade (top), automatically classified with machine learning (bottom).

Subsequently, the project demonstrated automatic categorization of LEE damage with the help of specially developed machine learning algorithms, see Figure 3.

The focus was on machine learning to predict LE erosion classes. Machine learning methods need a known output, also called a target (in this case the erosion class) and corresponding variable data, also called features. The starting point for collecting such data was a definition of erosion classes.

There are five classes, and membership of a class is defined by area (mm) and depth (mm) of the erosion. Since depth has to be measured, a specific sensor needed to be selected to generate feature data. To that end a 3D laser line scanner was used. For prototyping the method a suitable LE part of 1m length was provided. After scanning this part, the resulting image was divided in slices. Each slice was labeled manually with a the known erosion class. Then the resulting data set was split into a train and a test set. Training data was used to create the prediction model. For this purpose several machine learning methods were compared. The best performing model was used on the test set, which resulted in an accuracy of almost 65%. This looks very promising, but the dataset that was used was very small, and only held examples of erosion classes 1 and 2. Hence, the selected method and procedures proved to add value, but need to validated with more data, coming from several blades in several “health” states.

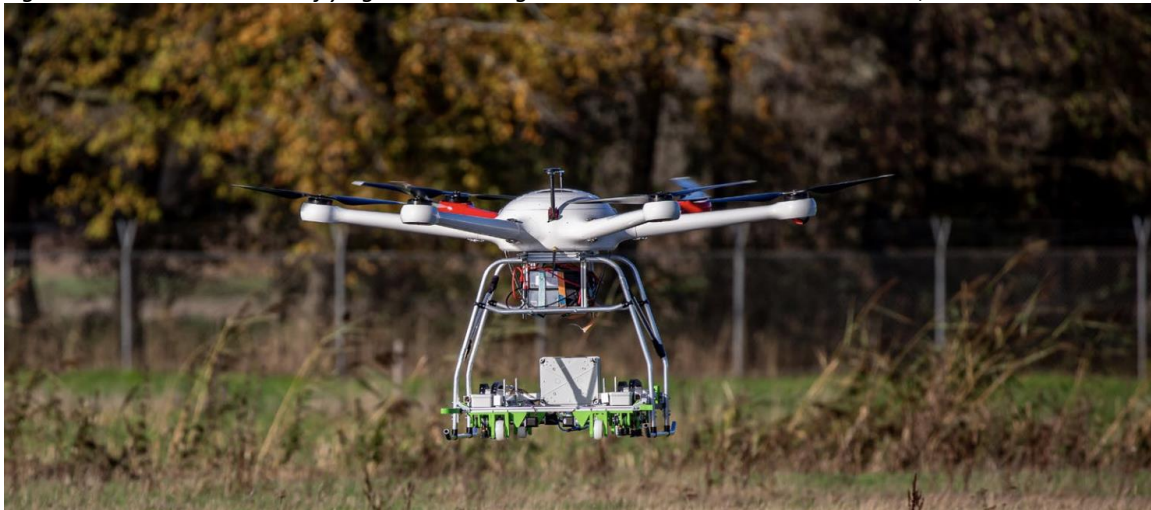
*Figure 7. Drone with crawler flying at NLR during the demonstration on November 24, 2022.*

In order to deploy the laserline scanner and the ultrasonic sensor, a drone with sufficient capacity (total take off weight of 40+ kg) was developed, see Figure 5. In addition to the drone, a crawler was developed by HZ-UAS. This crawler could be landed on the wind turbine blade by the drone and hold the ultrasonic sensor so it could take measurements. In order to stick to the blade, the crawler is equipped with a suction cups system.

Finally, a special flight controller has been developed by Fusion engineering. This flight controller has a non-linear control algorithm, allowing it to fly with a heavy drone very close to a wind turbine blade in gusty conditions.
